Fact sheet 4

Biomechanical Stabilization

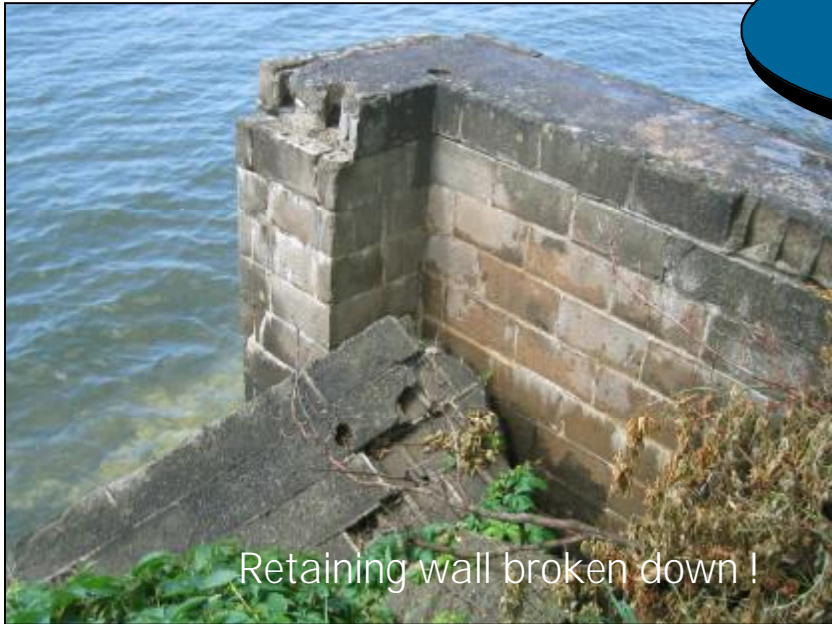
Retaining wall broken down !

Why the stabilizing wall is not an appropriate solution?

The concrete wall is forbidden in Québec since 1982. Its ban is based on the fact that this method harms the natural exchanges between aquatic and earthy environments. Wooden walls or gabions (fence cages filled with rocks) are less damageable to the water but do not last very long. If you possess an artificial it is highly recommended to vegetate it in order to restore the natural aspect to the shoreline. Planting Virginia creeper (five-leaved ivy) stabilizes the ground behind the wall, covers it and attracts birds and butterflies.

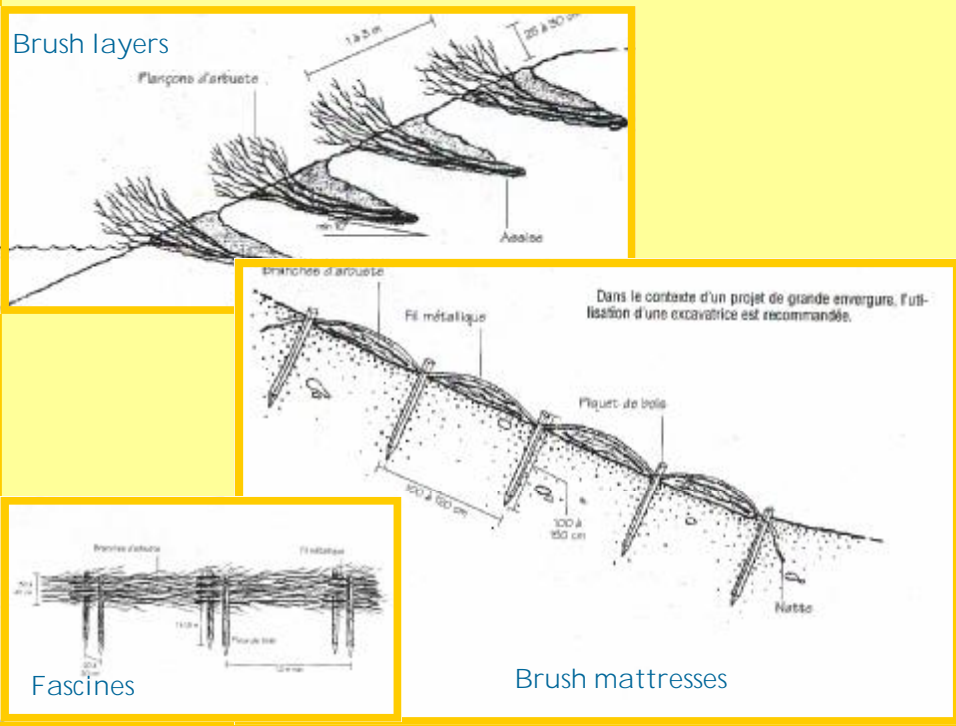
Three biomechanical techniques : brush layers, fascines and brush mattresses

The use of brush layers, fascines (bundle of long cuttings) or brush mattresses is lasting solution. These are vegetal engineering techniques, where we place attached branches on the bank and that we anchor* on the ground with posts. For not severe erosion, we propose plançons and fascines technics. For severe erosion, with waves and ice problems, we suggest branch layer solution. Those techniques must be completed with planting on the bank.
